Case Study: Root Cause on Seal Failure in Refinery

*Sourav Kumar Chatterjee
Sr. Manager Reliability Improvement
HPCL Mumbai Refinery
Mumbai, India*

Case A: Even a standby pump can have a seal failure, and a hazard associated with it

Case 2: Seal Failure of RCO Pump

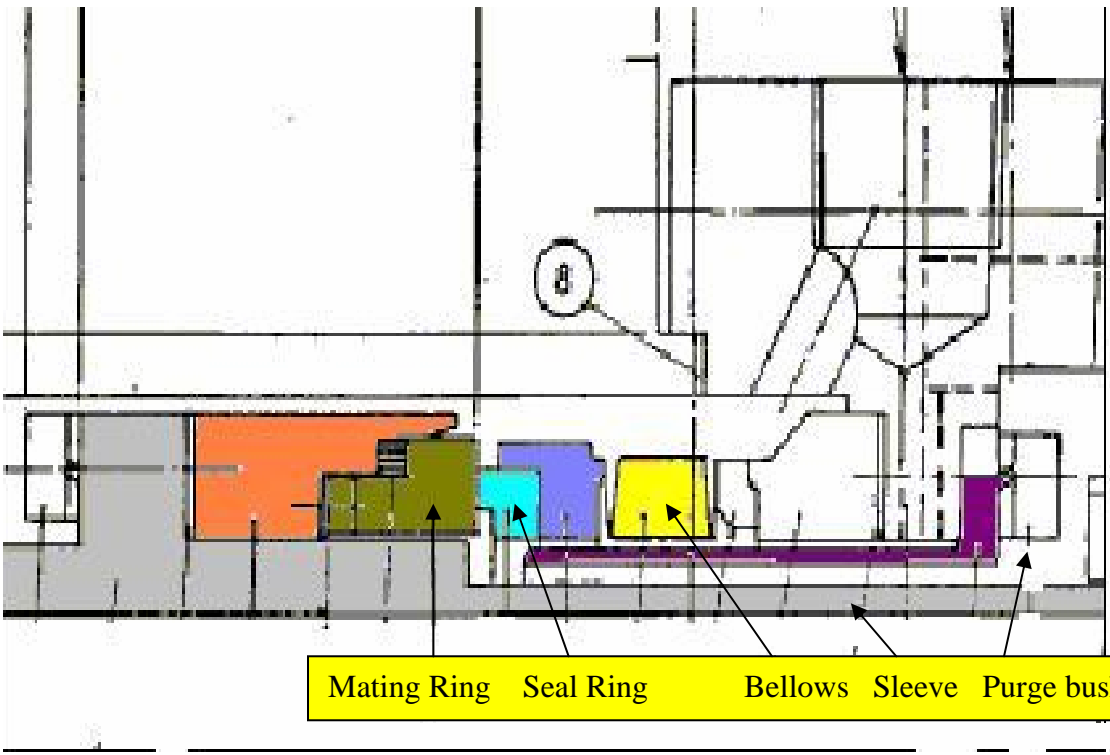
Pump type and operating parameters: single-stage centrifugal back pullout design, made by Thomson-Byrton. Flanges: 300# 4" suction, 3" discharge. Impeller has balancing holes.

Mating Ring Seal Ring Bellows Sleeve Purge bush

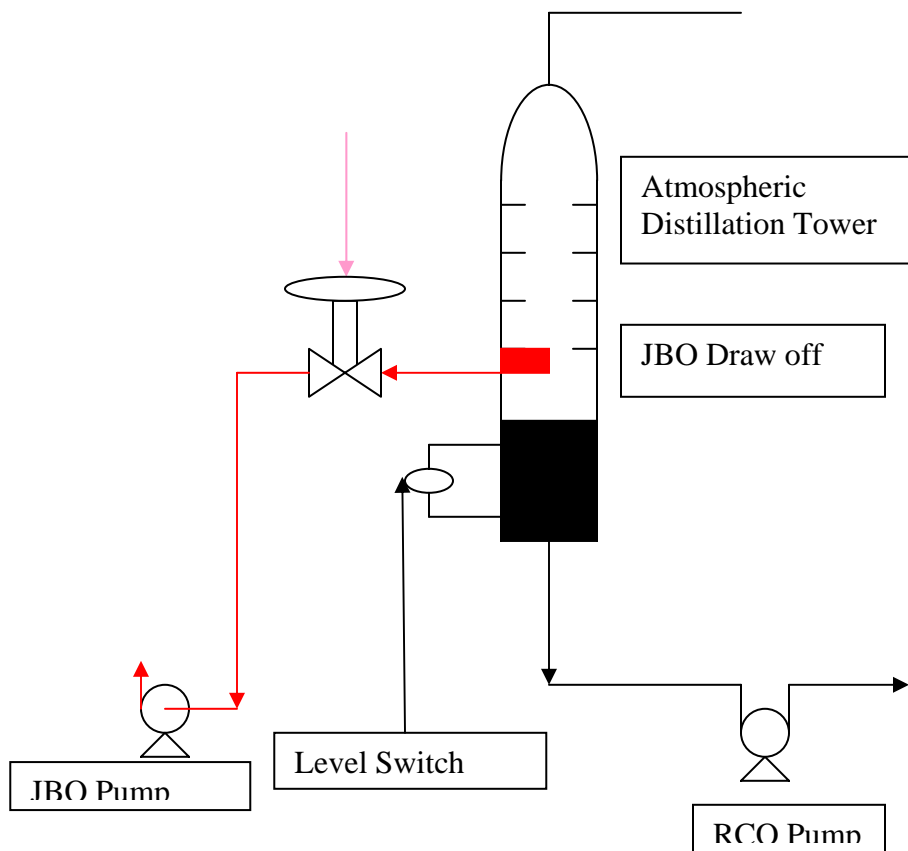
Two pumps are connected to the distillation tower. They are referred to as RCO (Reduced Crude Oil) pump and a JBO (the one described here) pump. Due to process yield requirements, the JBO pump operates at $17 \text{ m}^3/\text{hr}$, which is below the minimum flow requirement of $22 \text{ m}^3/\text{hr}$. In case the tank level drops below a certain value, the JBO draw-off control valve begins to close to raise the fluid level which is critical to RCO pump. Unfortunately, this causes problem for the JBO pump, which goes to cavitation leading to subsequent component failures under cavitation.

The JBO pump is fitted with single stationery bellow seal having face combination carbon vs. silicon carbide and initially the flushing plan was 02/62. The seal used to fail (“smoked”) very often indicating inadequate seal face cooling and twice seal failed under situation of starvation. This became highly alarming as the seal failure caused fire due to flashing of hot product in to atmosphere.

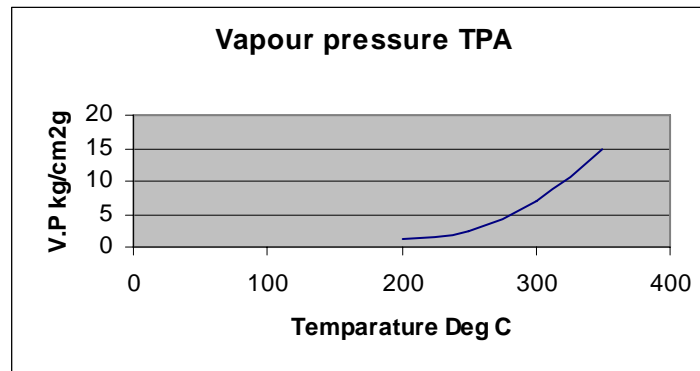
To curb the recurrence of such incident two immediate measures were taken:
Installed recirculation line
Provided external flushing Plan 32 with TPA media fluid (V.P 1.3 kg/cm² (gage) at 200 °C) at actual pressure of 4.5 kg/cm² at 150 °C was provided.
Seal box pressure was 3.2 kg/cm²

At first, this modification of system appeared to have solved the problem, **but again there was a seal blow-off event after three months.**

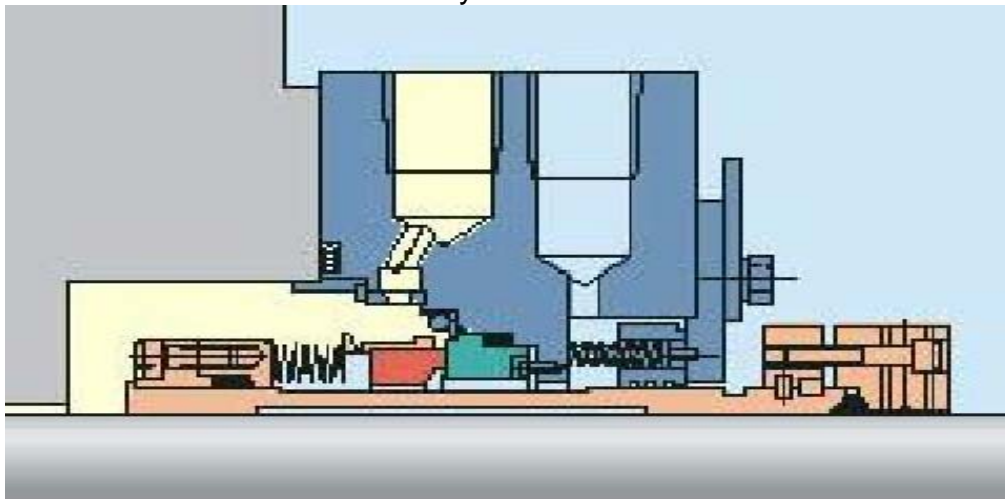
Seal: 2.750" Single PBR Cartridge Seal Make: FlowServe Sanmar

- 1.** Stuffing box pressure at NDE increased form 14 bar to 17 bar.

As per the seal vendor spec, the max pressure limit for bellows is 15 bar, which is the border line case and could likely be the cause of bellow failure.

Immediate actions: Recommended to change the bellows assembly material to Inconel with a bellows thickness of 8 mils to withstand higher pressure. The bellows mounting changed to stationery type from rotary type. Thus the rotor dynamics (due to torsion) loads and fatigue loads even in presence of any concentricity problem, will not affect the bellow stability.

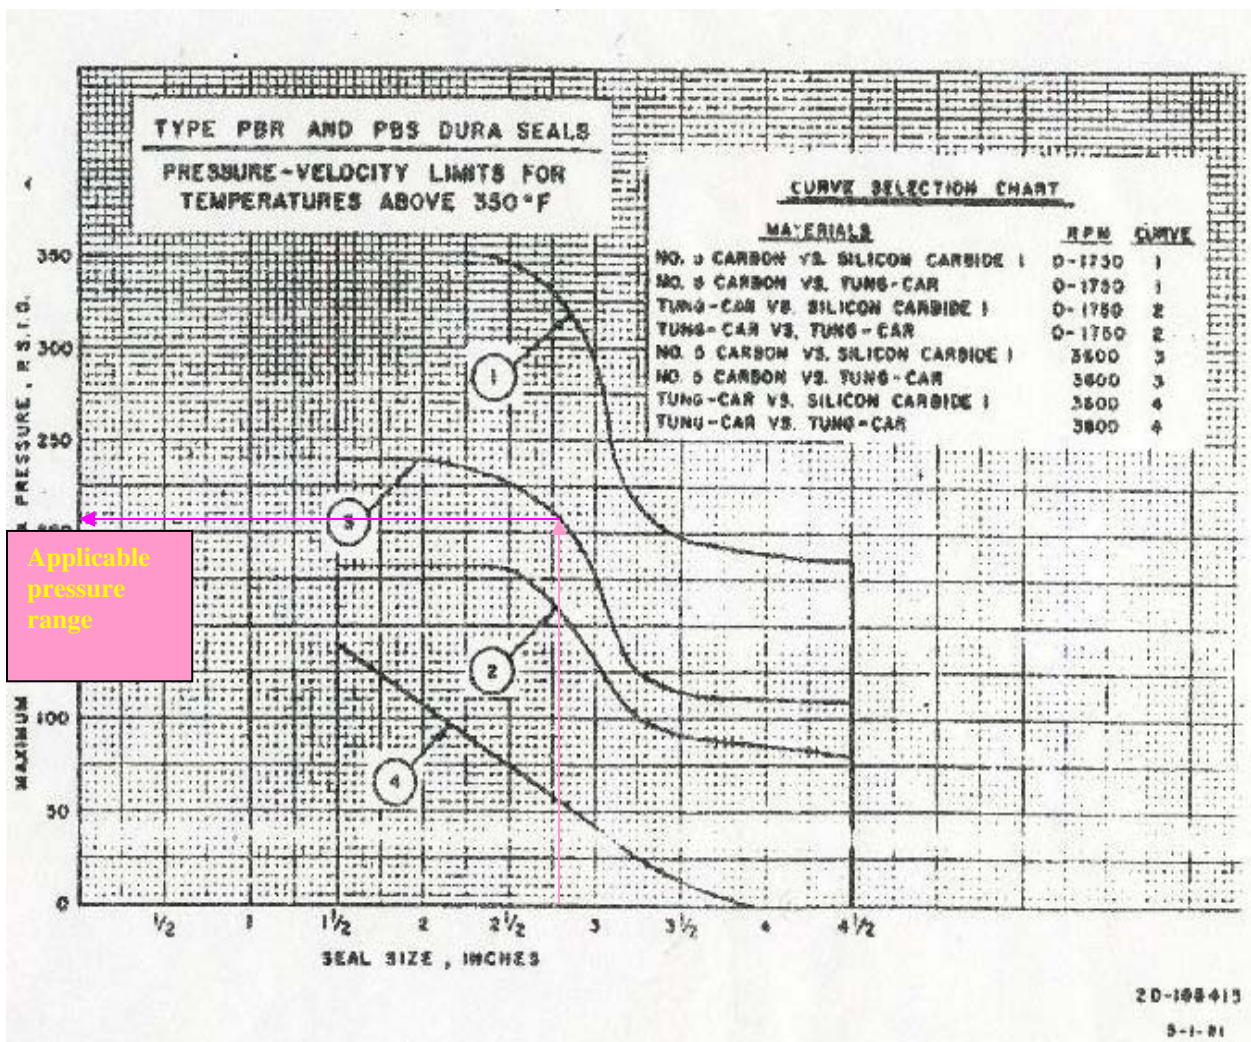
2. The pressure limit of PBR seal (4mils bellows AM350 ply thickness) as per the PV graph is 15 bar. The bellows did not develop this type of failure when the flushing Plans were 02/62 and the stuffing box pressures were around 14 bar. When the API Plan was changed to 32, the stuffing box pressures increased to 17-18 bar. As the Plan 32 pressure is more than the seal pressure allowable limit, it could cause over pressurization of the seal and eventually the seal will fail.
