Case Study: Root Cause on Seal Failure in Refinery

*Sourav Kumar Chatterjee
Sr. Manager Reliability Improvement
HPCL Mumbai Refinery
Mumbai, India*

Case A: Even a standby pump can have a seal failure, and a hazard associated with it

Case 2: Seal Failure of RCO Pump

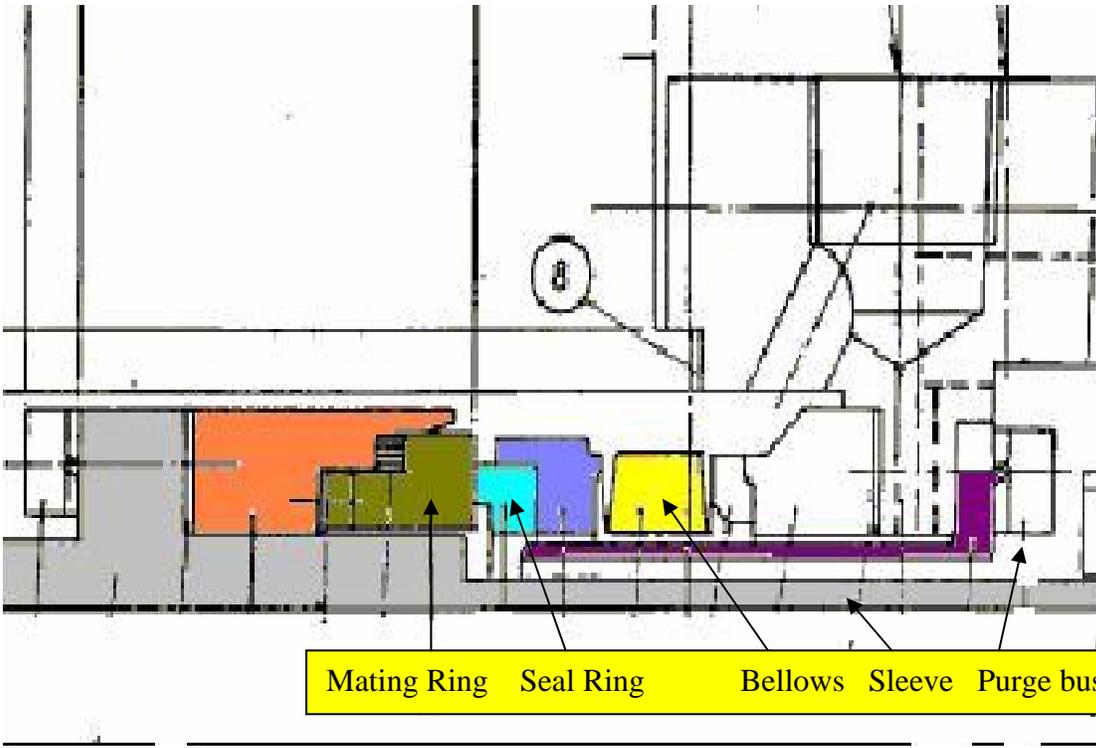
Mating Ring Seal Ring Bellows Sleeve Purge bush

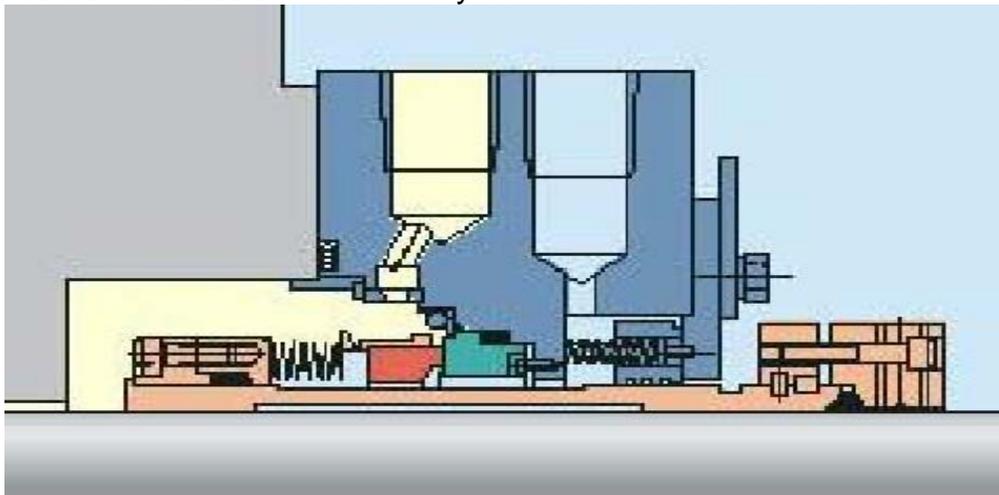
Seal: 2.750" Single PBR Cartridge Seal Make: FlowServe Sanmar

As per the seal vendor spec, the max pressure limit for bellows is 15 bar, which is the border line case and could likely be the cause of bellow failure.

2. The pressure limit of PBR seal (4mils bellows AM350 ply thickness) as per the PV graph is 15 bar. The bellows did not develop this type of failure when the flushing Plans were 02/62 and the stuffing box pressures were around 14 bar. When the API Plan was changed to 32, the stuffing box pressures increased to 17-18 bar. As the Plan 32 pressure is more than the seal pressure allowable limit, it could cause over pressurization of the seal and eventually the seal will fail.

Immediate actions: Recommended to change the bellows assembly material to Inconel with a bellows thickness of 8 mils to withstand higher pressure. The bellows mounting changed to stationery type from rotary type. Thus the rotor dynamics (due to torsion) loads and fatigue loads even in presence of any concentricity problem, will not affect the bellow stability.
