Case Study: Root Cause on Seal Failure in Refinery

*Sourav Kumar Chatterjee
Sr. Manager Reliability Improvement
HPCL Mumbai Refinery
Mumbai, India*

Case A: Even a standby pump can have a seal failure, and a hazard associated with it

Case 2: Seal Failure of RCO Pump

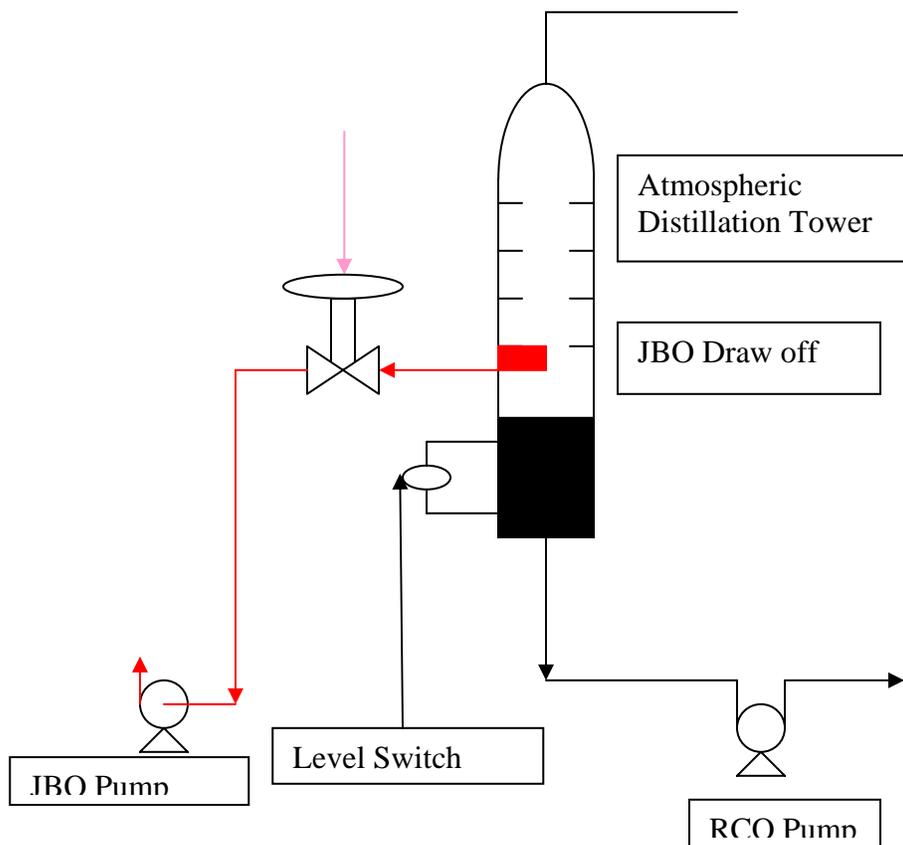
Two pumps are connected to the distillation tower. They are referred to as RCO (Reduced Crude Oil) pump and a JBO (the one described here) pump. Due to process yield requirements, the JBO pump operates at $17 \text{ m}^3/\text{hr}$, which is below the minimum flow requirement of $22 \text{ m}^3/\text{hr}$. In case the tank level drops below a certain value, the JBO draw-off control valve begins to close to raise the fluid level which is critical to RCO pump. Unfortunately, this causes problem for the JBO pump, which goes to cavitation leading to subsequent component failures under cavitation.

The JBO pump is fitted with single stationery bellow seal having face combination carbon vs. silicon carbide and initially the flushing plan was 02/62. The seal used to fail (“smoked”) very often indicating inadequate seal face cooling and twice seal failed under situation of starvation. This became highly alarming as the seal failure caused fire due to flashing of hot product in to atmosphere.

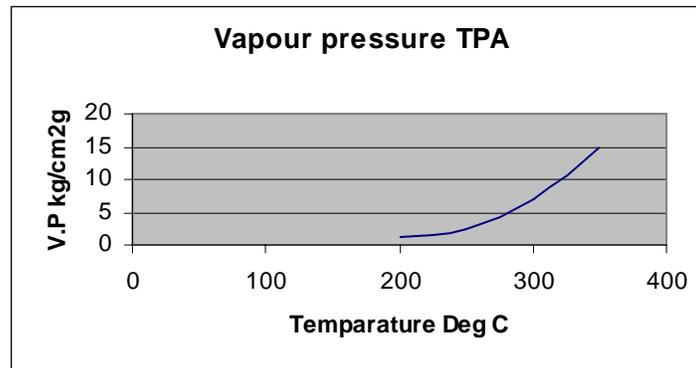
At first, this modification of system appeared to have solved the problem, **but again there was a seal blow-off event after three months.**

To curb the recurrence of such incident two immediate measures were taken:
Installed recirculation line
Provided external flushing Plan 32 with TPA media fluid (V.P 1.3 kg/cm² (gage) at 200 °C) at actual pressure of 4.5 kg/cm² at 150 °C was provided.
Seal box pressure was 3.2 kg/cm²
